CHECK OUT INSPECTION

25 Park Way, Caversham, Reading, Berkshire, RG1 2KY

30/01/2019

2 Bedrooms Unfurnished Property

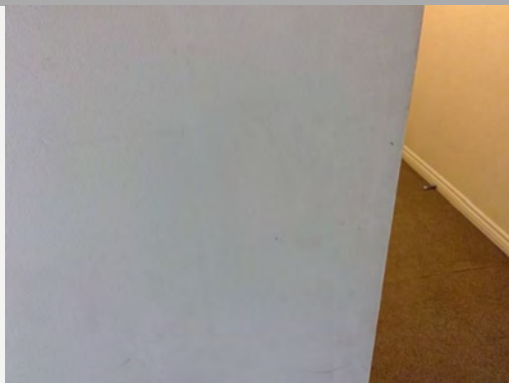
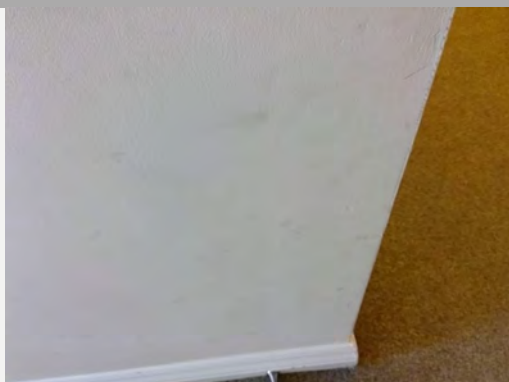
Entrance Hall - Walls

Name	No.	Description	Condition	Check Out Condition	T	L	F
Walls	4	Walls are smooth painted cream with white wooden skirting. [2 chrome doorstops to entrance,] 3 chrome doorstops fitted to the entrance area 1. Indents to the plaster to left wall behind door with light scuffs around, further light scuff marks to mid and lower level to the right-hand of entrance. Further light scuff marks with touch-up paint and patchy paint noticeable to the left. Scuff marks to wall edge to the right with heavy overpainted defect to the left of bathroom door. Continuation of the patchy paint to the last part of the entrance hall, light chips to wall edges. Scuff marks to the paintwork between bedroom 2 and cupboard door.	Used	White tip missing to doorstop.	<input checked="" type="checkbox"/>	<input type="checkbox"/>	<input type="checkbox"/>
Floors	5	Brown fitted carpet, join gaps seen. Furniture indentations noticed, has been professionally cleaned. Signs of lifting near reception door.	Used	Black staining visible to left wall	<input checked="" type="checkbox"/>	<input type="checkbox"/>	<input type="checkbox"/>

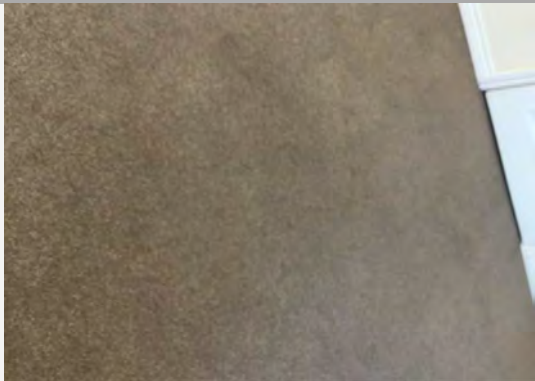
Reception Room - Floors

Name	No.	Description	Condition	Check Out Condition	T	L	F
Floors	14	Continuation of carpet, heavy indentations seen, lifting noticed.	Used	Yellow stain can be seen to centre	<input checked="" type="checkbox"/>	<input type="checkbox"/>	<input type="checkbox"/>

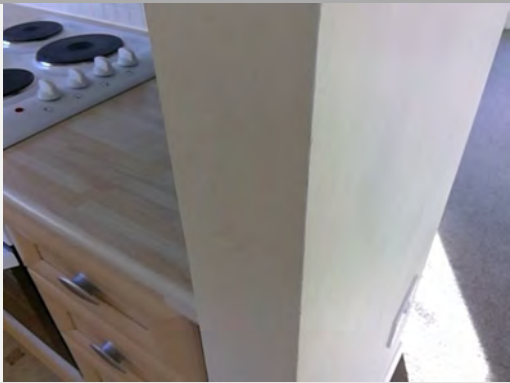
Kitchen - Walls

Name	No.	Description	Condition	Check Out Condition	T	L	F
Walls	21	Cream smooth painted walls with white ceramic mosaic tiles, marks to the right side to entrance. White spot marks to left-hand wall and just above skirting, water marks seen to skirtings to the open area under window. Dust to the top of tiles by window	Used	Heavy Scuff mark can be seen to left wall with various marks from mid to low-level.	<input checked="" type="checkbox"/>	<input type="checkbox"/>	<input type="checkbox"/>
Fridge/ Freezer	29	Integrated fridge/freezer, fridge, 4 glass shelves with white plastic edging, 1 crisp drawer, door shelves have 3 full door shelves, top shelf with lid; freezer has frost-free pull-out tray with further 3 trays; all professionally cleaned.	Used	Crack visible to compartment to door. Damage can be seen to pull out drawer within freezer	<input checked="" type="checkbox"/>	<input type="checkbox"/>	<input type="checkbox"/>

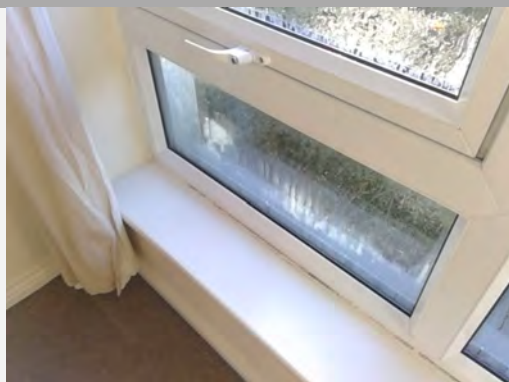
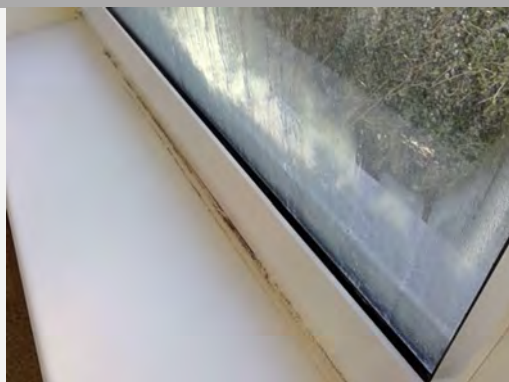
Reception Room - Windows and Window Fittings

Name	No.	Description	Condition	Check Out Condition	T	L	F
Windows and Window Fittings	15	White UPVC windows, 2 sets of double openers with white handles, window vents fitted, enclosed panels underneath; exterior side of the glass requires cleaning; [windowsill-type], blackened to the corners, marks to the top. Heavy black spot marks to the sealants, matching chrome curtain poles with finials, floor-length beige/cream eyelet curtains, curtains are creased.	Used	Condensation can be seen within glass panes. Curtain rail coming away to right side to window to facing wall	<input type="checkbox"/>	<input checked="" type="checkbox"/>	<input type="checkbox"/>

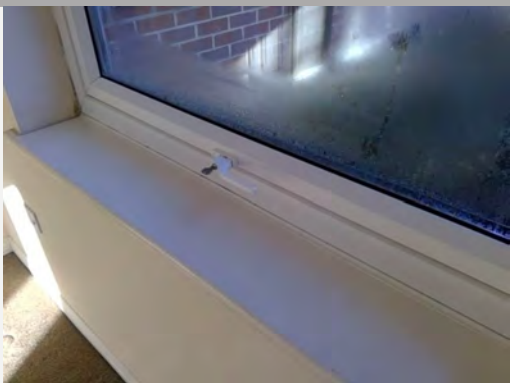
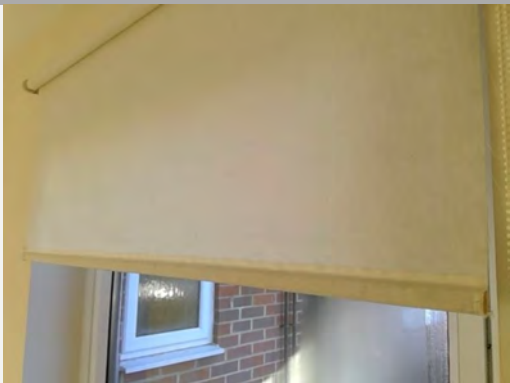
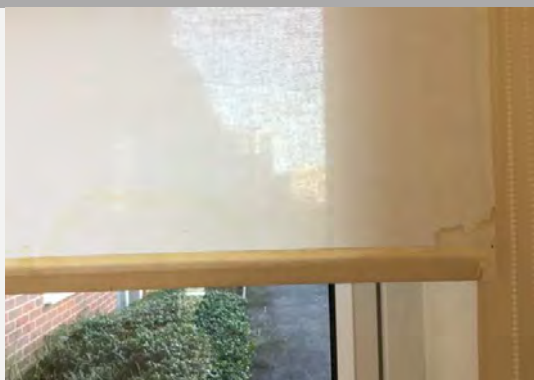
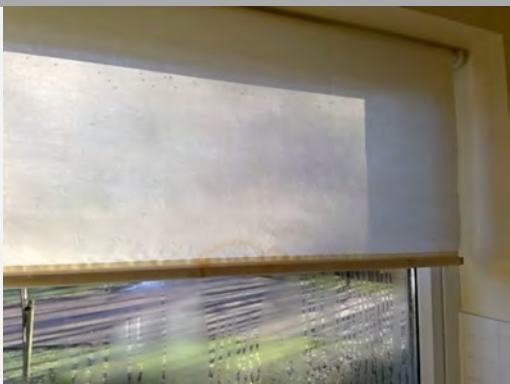
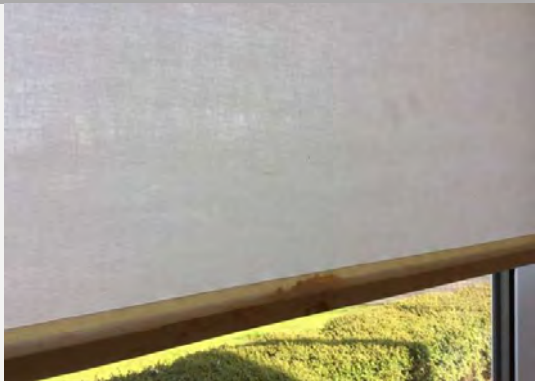
Kitchen - Windows & Window Fittings

Name	No.	Description	Condition	Check Out Condition	T	L	F
Windows & Window Fittings	23	White UPVC windows, 2 sets; white handle, heavy blackening spot marks to the sealant to the corners; white rolled-edge windowsill and ceramic tiles to the kitchen by sink. Key present; white roller blind, plastic pull cord, not with a child breakage cord, water marks seen. Marks to frame; water marks to the white roller blind, no cleat fitted; black spot marks to the sealant, heavier to the right corner.	Used	No safety catch visible to blind	<input type="checkbox"/>	<input checked="" type="checkbox"/>	<input type="checkbox"/>

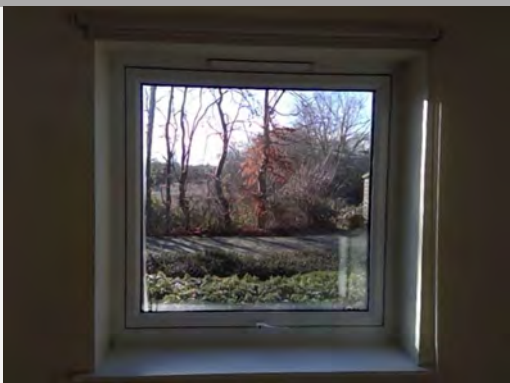
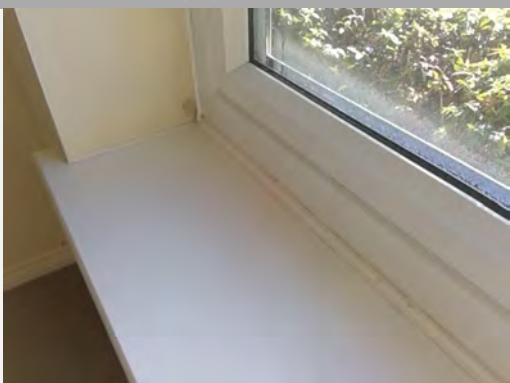
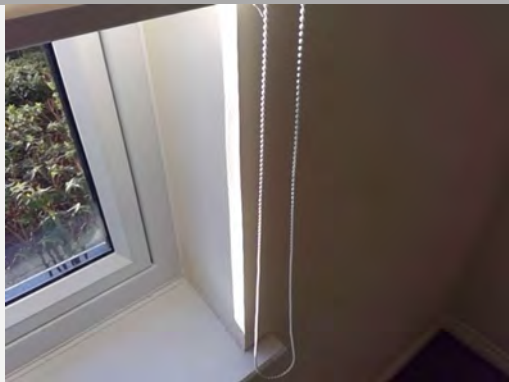
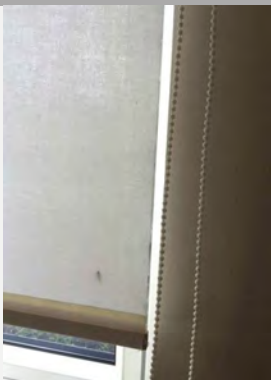
Bedroom 2 - Windows and Window Fittings

Name	No.	Description	Condition	Check Out Condition	T	L	F
Windows and Window Fittings	43	White UPVC window with white handle; white painted windowsill, blackening spots to the sealant; white roller blind with plastic pull cord. Blackening to the sealant to top left corner, fraying to the roller blind to the edge with black spot mark.	Used	No safety clasp has been fitted to roller blind chain	<input type="checkbox"/>	<input checked="" type="checkbox"/>	<input type="checkbox"/>

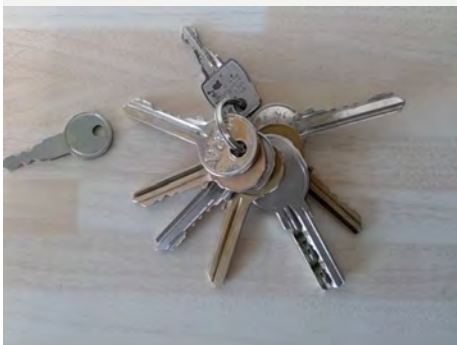
Keys at Check Out
3 x communal door keys
3 x apartment door keys
1 x post box key
1 x window key
1 x back entrance key

(ONE BACK ENTRANCE KEY MISSING)
