CHECK OUT INSPECTION

25 Park Way, Caversham, Reading, Berkshire, RG1 2KY

30/01/2019

2 Bedrooms Unfurnished Property

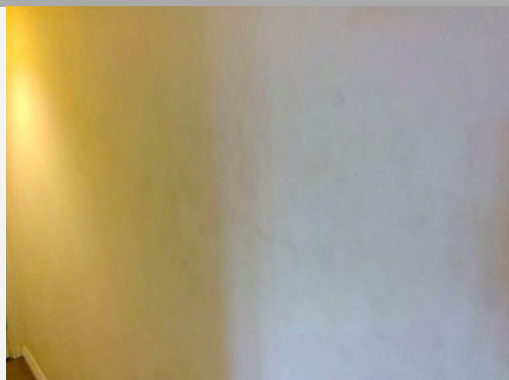
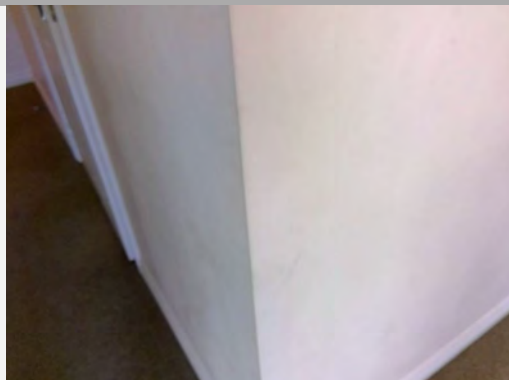
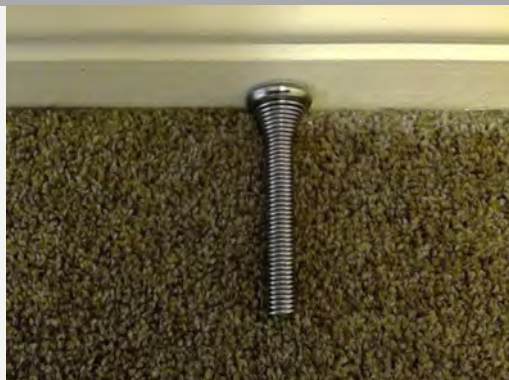
Name	No.	Description	Condition	Check Out Condition	T	L	F
Walls	4	Walls are smooth painted cream with white wooden skirting. [2 chrome doorstops to entrance,] 3 chrome doorstops fitted to the entrance area 1. Indents to the plaster to left wall behind door with light scuffs around, further light scuff marks to mid and lower level to the right-hand of entrance. Further light scuff marks with touch-up paint and patchy paint noticeable to the left. Scuff marks to wall edge to the right with heavy overpainted defect to the left of bathroom door. Continuation of the patchy paint to the last part of the entrance hall, light chips to wall edges. Scuff marks to the paintwork between bedroom 2 and cupboard door.	Used	White tip missing to doorstop.	<input checked="" type="checkbox"/>	<input type="checkbox"/>	<input type="checkbox"/>
Floors	5	Brown fitted carpet, join gaps seen. Furniture indentations noticed, has been professionally cleaned. Signs of lifting near reception door.	Used	Black staining visible to left wall	<input checked="" type="checkbox"/>	<input type="checkbox"/>	<input type="checkbox"/>

Name	No.	Description	Condition	Check Out Condition
Ceiling	3	White smooth painted ceiling. Patchy paint noticeable.	Used	Consistent with inventory
Walls	4	<p>Walls are smooth painted cream with white wooden skirting.</p> <p>[2 chrome doorstops to entrance,] 3 chrome doorstops fitted to the entrance area 1.</p> <p>Indents to the plaster to left wall behind door with light scuffs around, further light scuff marks to mid and lower level to the right-hand of entrance.</p> <p>Further light scuff marks with touch-up paint and patchy paint noticeable to the left.</p> <p>Scuff marks to wall edge to the right with heavy overpainted defect to the left of bathroom door.</p> <p>Continuation of the patchy paint to the last part of the entrance hall, light chips to wall edges.</p> <p>Scuff marks to the paintwork between bedroom 2 and cupboard door.</p>	Used	White tip missing to doorstep.
Floors	5	<p>Brown fitted carpet, join gaps seen.</p> <p>Furniture indentations noticed, has been professionally cleaned.</p> <p>Signs of lifting near reception door.</p>	Used	Black staining visible to left wall

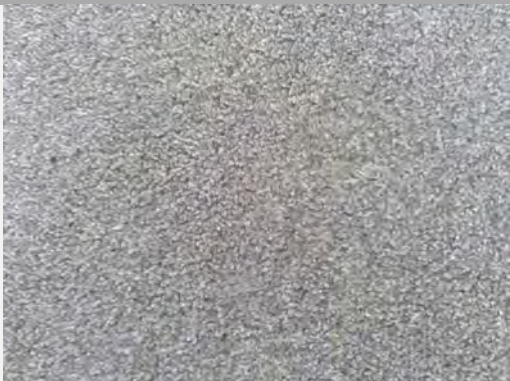
<div>14.6</div>
<div>08/03/2017 19:18:28</div>

Name	No.	Description	Condition	Check Out Condition	T	L	F
Floors	14	Continuation of carpet, heavy indentations seen, lifting noticed.	Used	Yellow stain can be seen to centre	<input checked="" type="checkbox"/>	<input type="checkbox"/>	<input type="checkbox"/>

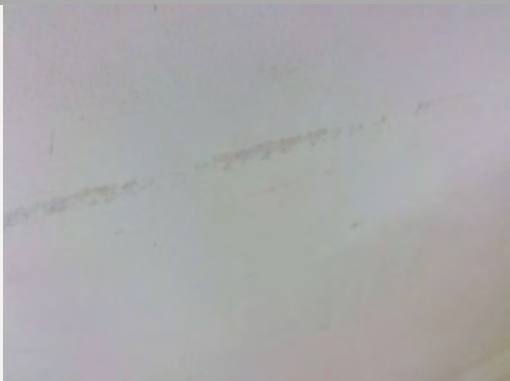
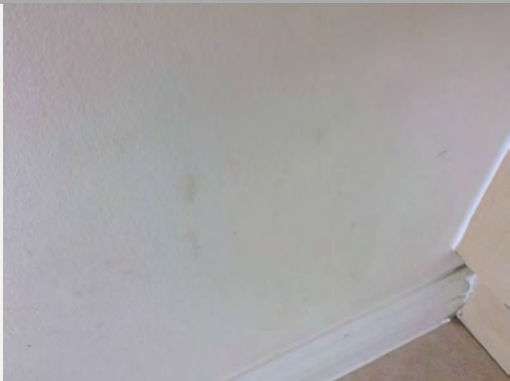
Name	No.	Description	Condition	Check Out Condition	T	L	F
Walls	21	Cream smooth painted walls with white ceramic mosaic tiles, marks to the right side to entrance. White spot marks to left-hand wall and just above skirting, water marks seen to skirtings to the open area under window. Dust to the top of tiles by window	Used	Heavy Scuff mark can be seen to left wall with various marks from mid to low-level.	<input checked="" type="checkbox"/>	<input type="checkbox"/>	<input type="checkbox"/>
Fridge/ Freezer	29	Integrated fridge/freezer, fridge, 4 glass shelves with white plastic edging, 1 crisp drawer, door shelves have 3 full door shelves, top shelf with lid; freezer has frost-free pull-out tray with further 3 trays; all professionally cleaned.	Used	Crack visible to compartment to door. Damage can be seen to pull out drawer within freezer	<input checked="" type="checkbox"/>	<input type="checkbox"/>	<input type="checkbox"/>

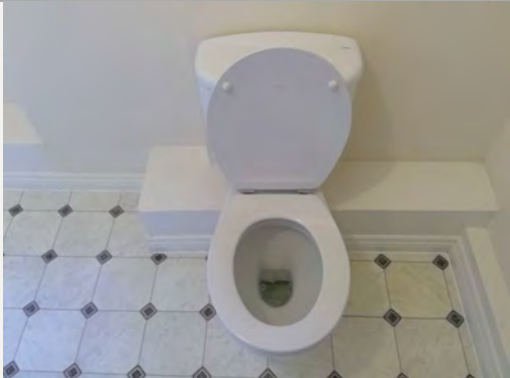
<div>56.4</div>
<div>08/03/2017 19:07:54</div>

Name	No.	Description	Condition	Check Out Condition	T	L	F
Toilet	56	White WC Roca toilet; chrome push-in flusher, short and large; white plastic toilet seat, flusher working, bowl clean. Light marks to the sealant around pedestal.	Used	Hairline crack can be seen to back of the toilet	<input checked="" type="checkbox"/>	<input type="checkbox"/>	<input type="checkbox"/>

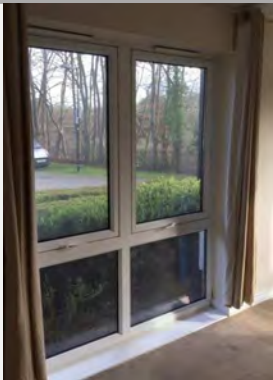
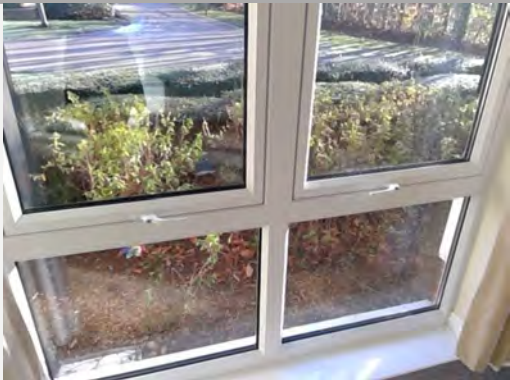
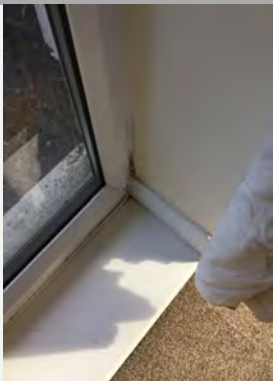
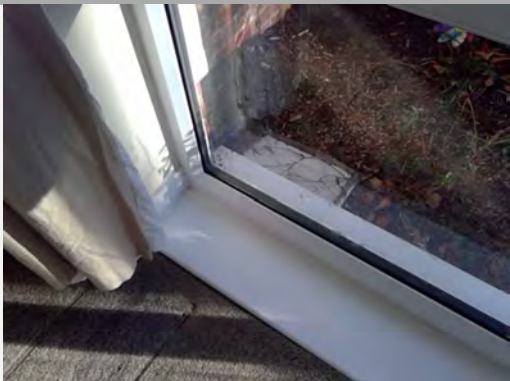
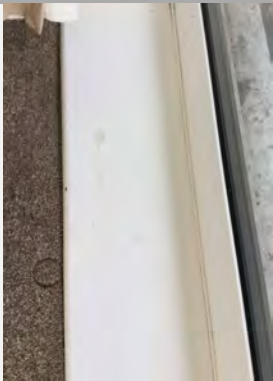
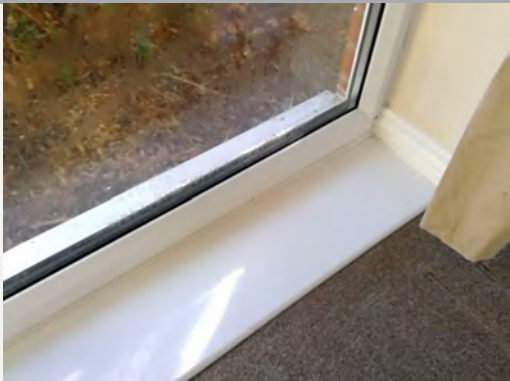
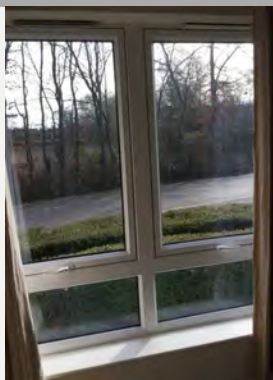
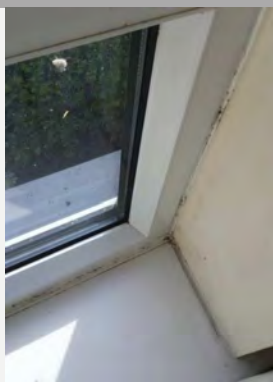
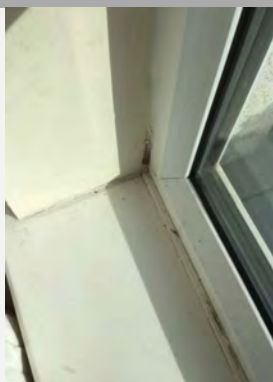
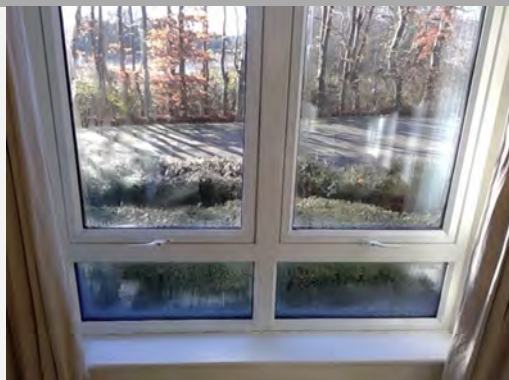
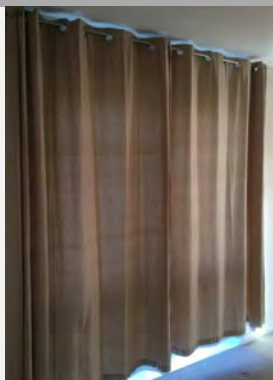
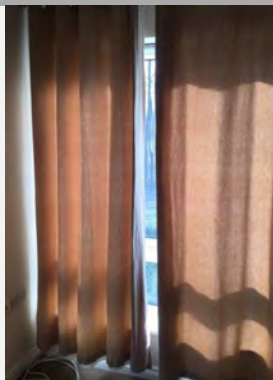
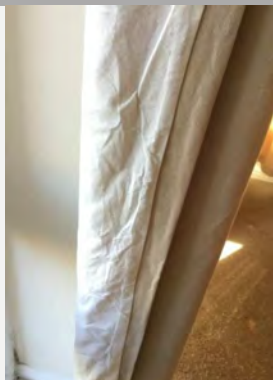
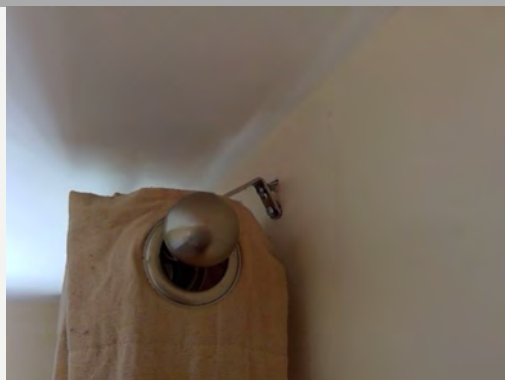
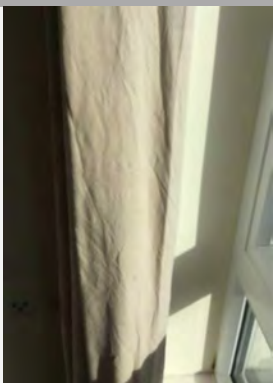
Reception Room - Windows and Window Fittings

Name	No.	Description	Condition	Check Out Condition	T	L	F
Windows and Window Fittings	15	White UPVC windows, 2 sets of double openers with white handles, window vents fitted, enclosed panels underneath; exterior side of the glass requires cleaning; [windowsill-type], blackened to the corners, marks to the top. Heavy black spot marks to the sealants, matching chrome curtain poles with finials, floor-length beige/cream eyelet curtains, curtains are creased.	Used	Condensation can be seen within glass panes. Curtain rail coming away to right side to window to facing wall	<input type="checkbox"/>	<input checked="" type="checkbox"/>	<input type="checkbox"/>

Name	No.	Description	Condition	Check Out Condition
Windows and Window Fittings	15	White UPVC windows, 2 sets of double openers with white handles, window vents fitted, enclosed panels underneath; exterior side of the glass requires cleaning; [windowsill-type], blackened to the corners, marks to the top. Heavy black spot marks to the sealants, matching chrome curtain poles with finials, floor-length beige/cream eyelet curtains, curtains are creased.	Used	Condensation can be seen within glass panes. Curtain rail coming away to right side to window to facing wall

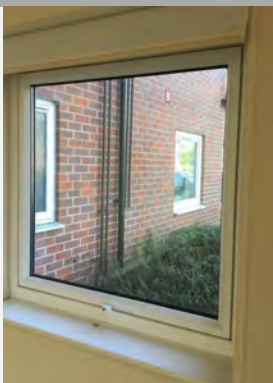
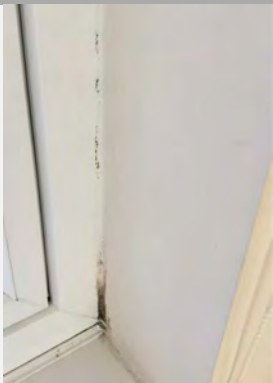
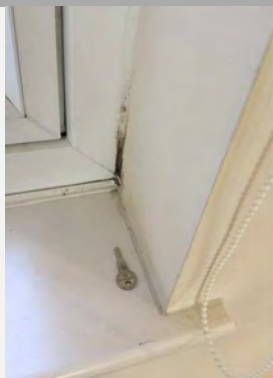
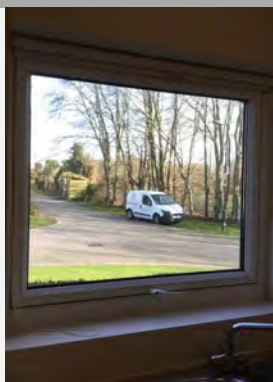
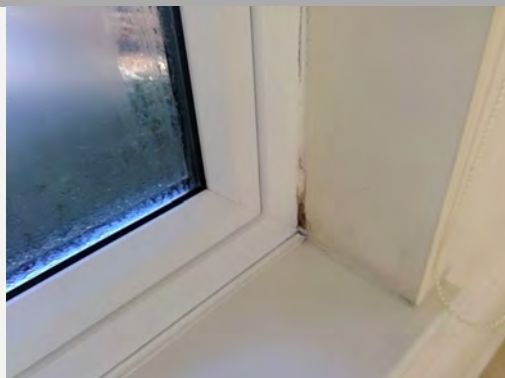
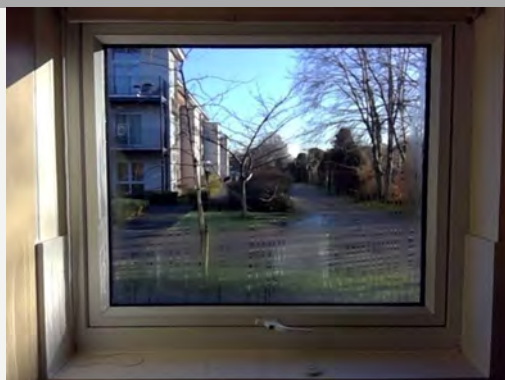
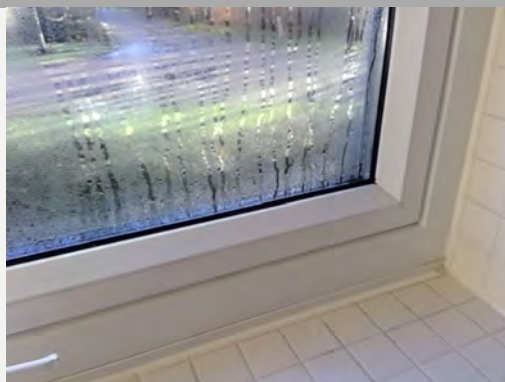
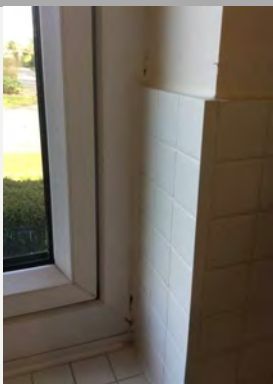
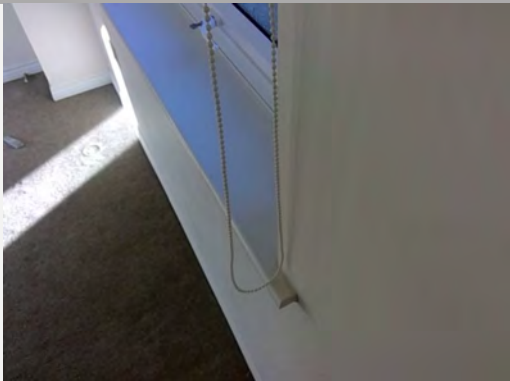
Kitchen - Windows & Window Fittings

Name	No.	Description	Condition	Check Out Condition	T	L	F
Windows & Window Fittings	23	White UPVC windows, 2 sets; white handle, heavy blackening spot marks to the sealant to the corners; white rolled-edge windowsill and ceramic tiles to the kitchen by sink. Key present; white roller blind, plastic pull cord, not with a child breakage cord, water marks seen. Marks to frame; water marks to the white roller blind, no cleat fitted; black spot marks to the sealant, heavier to the right corner.	Used	No safety catch visible to blind	<input type="checkbox"/>	<input checked="" type="checkbox"/>	<input type="checkbox"/>

Name	No.	Description	Condition	Check Out Condition
Windows & Window Fittings	23	White UPVC windows, 2 sets; white handle, heavy blackening spot marks to the sealant to the corners; white rolled-edge windowsill and ceramic tiles to the kitchen by sink. Key present; white roller blind, plastic pull cord, not with a child breakage cord, water marks seen. Marks to frame; water marks to the white roller blind, no cleat fitted; black spot marks to the sealant, heavier to the right corner.	Used	No safety catch visible to blind

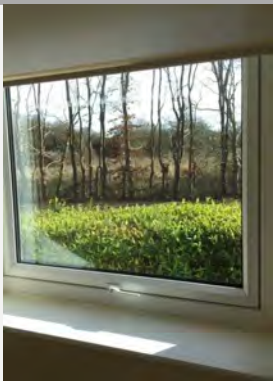
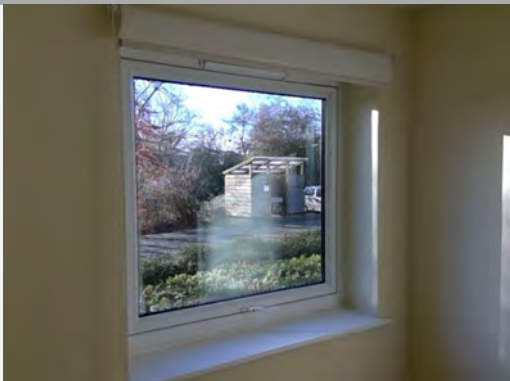
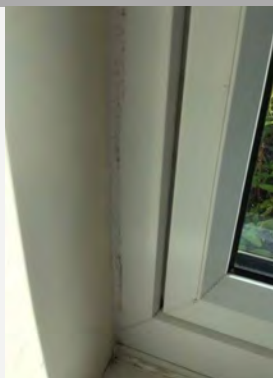
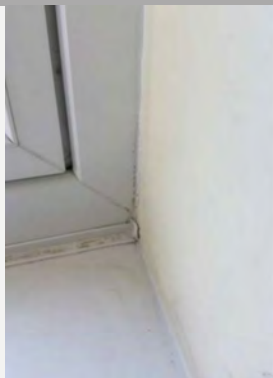
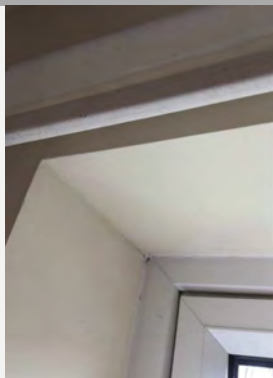
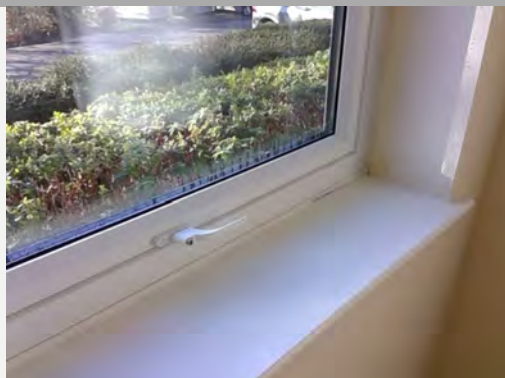
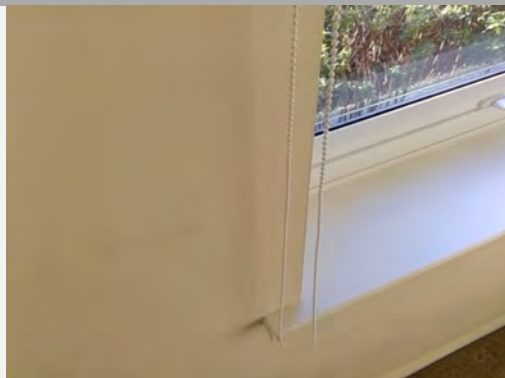
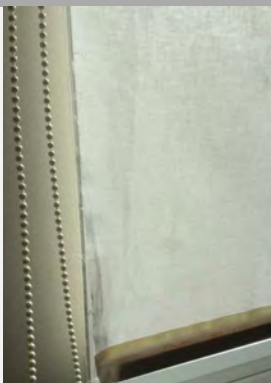
Bedroom - Windows and Window Fittings

Name	No.	Description	Condition	Check Out Condition	T	L	F
Windows and Window Fittings	35	White UPVC window, white handle, white UPVC frame, marks to sealant, white rolled-edge windowsill. Black spots are inside of the frame and underneath frame. Window vent fitted. Small hairline crack to recess of the wall, top left corner. White roller blind, fitted frame to the edge, not breakable plastic pull cord, no cleat	Used	No safety catch visible to roller blind chain	<input type="checkbox"/>	<input checked="" type="checkbox"/>	<input type="checkbox"/>

Name	No.	Description	Condition	Check Out Condition
Windows and Window Fittings	35	<p>White UPVC window, white handle, white UPVC frame, marks to sealant, white rolled-edge windowsill.</p> <p>Black spots are inside of the frame and underneath frame.</p> <p>Window vent fitted.</p> <p>Small hairline crack to recess of the wall, top left corner.</p> <p>White roller blind, fitted frame to the edge, not breakable plastic pull cord, no cleat</p>	Used	No safety catch visible to roller blind chain

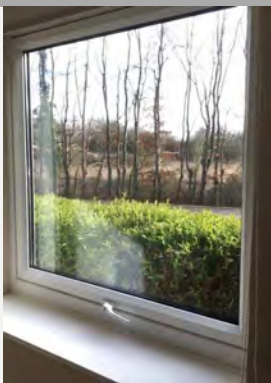
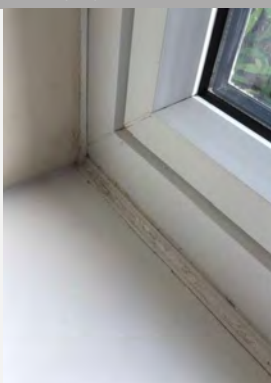
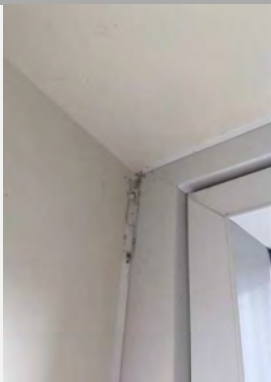
Bedroom 2 - Windows and Window Fittings

Name	No.	Description	Condition	Check Out Condition	T	L	F
Windows and Window Fittings	43	White UPVC window with white handle; white painted windowsill, blackening spots to the sealant; white roller blind with plastic pull cord. Blackening to the sealant to top left corner, fraying to the roller blind to the edge with black spot mark.	Used	No safety clasp has been fitted to roller blind chain	<input type="checkbox"/>	<input checked="" type="checkbox"/>	<input type="checkbox"/>

Name	No.	Description	Condition	Check Out Condition
Windows and Window Fittings	43	White UPVC window with white handle; white painted windowsill, blackening spots to the sealant; white roller blind with plastic pull cord. Blackening to the sealant to top left corner, fraying to the roller blind to the edge with black spot mark.	Used	No safety clasp has been fitted to roller blind chain

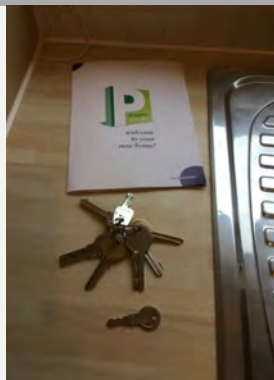
2 X sets of keys, each set has 1 front and back building door key, front door key with 1 post box key to one of the sets. 1 window key
Welcome Pack explained

(ONE BACK ENTRANCE KEY MISSING)

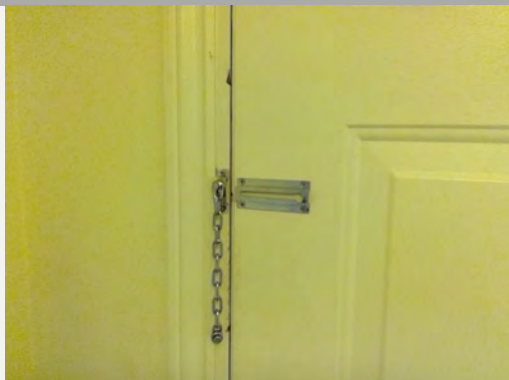
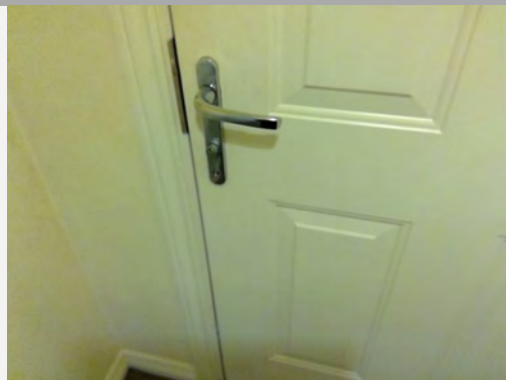
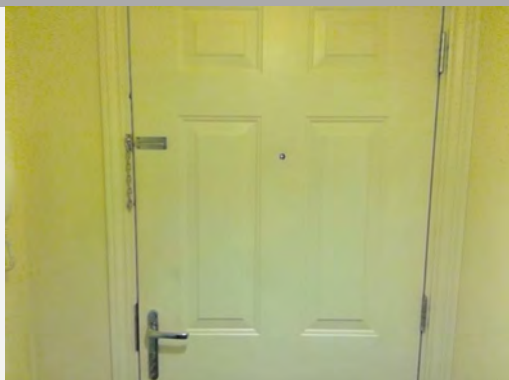
Name	No.	Description	Condition	Check Out Condition
Entrance Hall	1			Consistent with inventory
Doors & Woodwork	2	<p>White panelled door with chrome door furnishings, no number. Damage to the edge</p> <p>Interior side is a chain security sliding bolt, reverse of chrome handle, spy hole with chrome fire door hinge.</p> <p>Door frame is white, light chips seen by the security chain, heavier above; blackening to the hinges, indent marks and scuff marks to the bottom, left and right.</p> <p>Exterior side of door: scuff marks lower level; cream entrance mat, spot marks seen.</p>	Used	Consistent with inventory

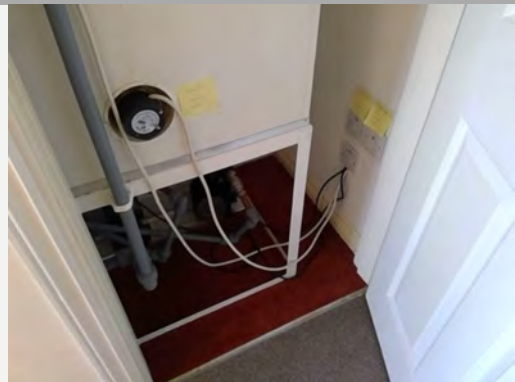
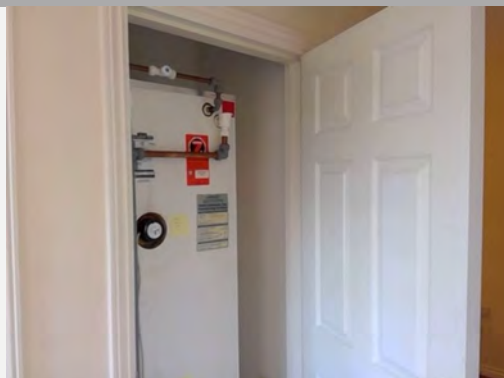
Name	No.	Description	Condition	Check Out Condition
Cupboard	8	White wooden panel door with grain-effect, door frame painted white, chrome pull down lever handle; interior side of the door: reverse of handle, light discolouration to the colour; dark terracotta carpet, white smooth painted walls with floor-standing combi tank and boiler, various white-fronted switches seen; exposed pipework, lagged and unlagged.	Used	Consistent with inventory
Cupboard 2	9	White panel door wood grain-effect, white door frame, chrome pull down lever handle; light chip to the paint to the exterior side bottom left corner to the frame. Interior side of door: reverse of handle, metal threshold, continuation of the carpet. Cream smooth painted walls, heavy brown marks seen with skirting, missed cut-out to the facing, light scuff marks upper level; 2 sets of fuse boxes seen.	Used	Consistent with inventory

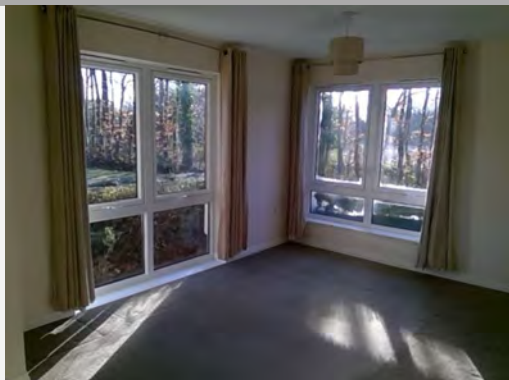
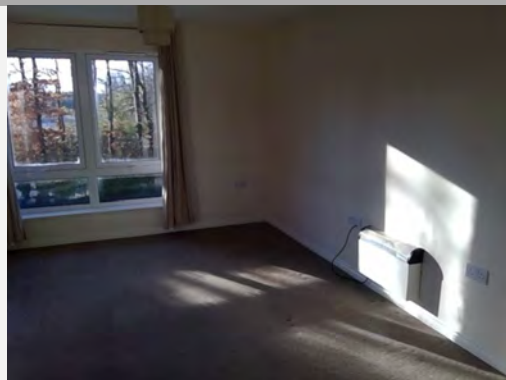
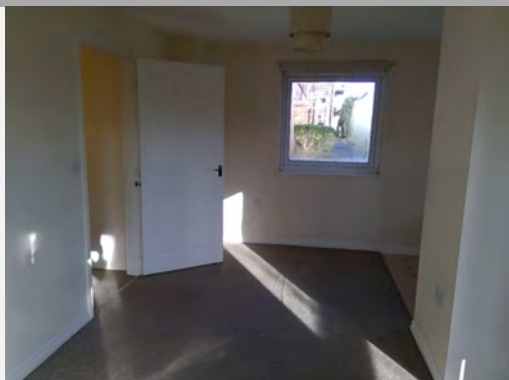
Name	No.	Description	Condition	Check Out Condition
Reception Room	10			Consistent with inventory
Doors & Woodwork	11	White panelled wood grain door with door frame, 3 scuff marks to the recess of the door to the right; metal threshold, fire door chain fitted; chrome pull down lever handle, light marks seen above handle. Interior side of door: reverse of door handle, door frame white, scratch by door handle, scuff marks to the left and right bottom panels.	Used	Consistent with inventory
Ceiling	12	White smooth painted ceiling. Light spot marks seen near light.	Used	Consistent with inventory

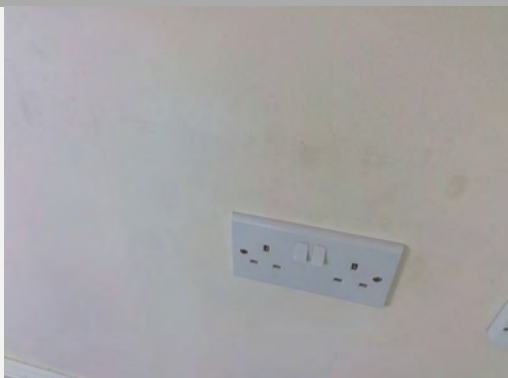
Name	No.	Description	Condition	Check Out Condition
Walls	13	Continuation of cream smooth painted walls with white wooden skirting; pilaster between kitchen and reception, indents marks seen, skirting is white wooden. Touch-up paint noticed with the white filler, finger marks and shade marks seen to the facing and right-hand wall. Yellow spot marks seen to the left-hand wall to the skirting and to the right of the pillar. Metal with white rubber doorstop seen, man-made cable hole to left and right walls. Cable and clips fitted to the left and facing wall.	Used	Consistent with inventory
Floors	14	Continuation of carpet, heavy indentations seen, lifting noticed.	Used	Yellow stain can be seen to centre
Windows and Window Fittings	15	White UPVC windows, 2 sets of double openers with white handles, window vents fitted, enclosed panels underneath; exterior side of the glass requires cleaning; [windowsill-type], blackened to the corners, marks to the top. Heavy black spot marks to the sealants, matching chrome curtain poles with finials, floor-length beige/cream eyelet curtains, curtains are creased.	Used	Condensation can be seen within glass panes. Curtain rail coming away to right side to window to facing wall

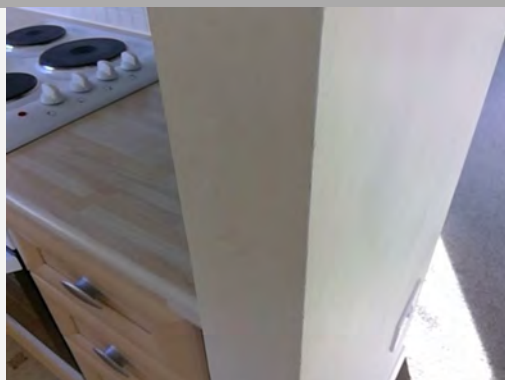
Name	No.	Description	Condition	Check Out Condition
Kitchen	18			Consistent with inventory
Doors & Woodwork	19	No door, open area from reception.	Used	Consistent with inventory
Ceiling	20	Continuation of white smooth painted ceiling.	Used	Consistent with inventory
Walls	21	Cream smooth painted walls with white ceramic mosaic tiles, marks to the right side to entrance. White spot marks to left-hand wall and just above skirting, water marks seen to skirtings to the open area under window. Dust to the top of tiles by window	Used	Heavy Scuff mark can be seen to left wall with various marks from mid to low-level.
Floor	22	Vinyl flooring, beige with tile-effect, lifting under open area, with torn area, marks to the left. Damage to the open area left side of oven, lifting to the left side of sink.	Damaged	Consistent with inventory

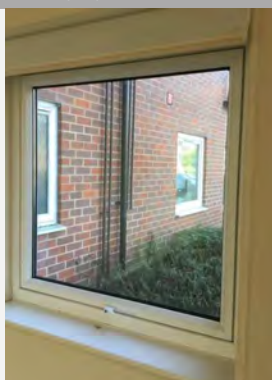
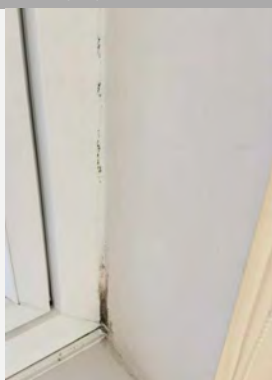
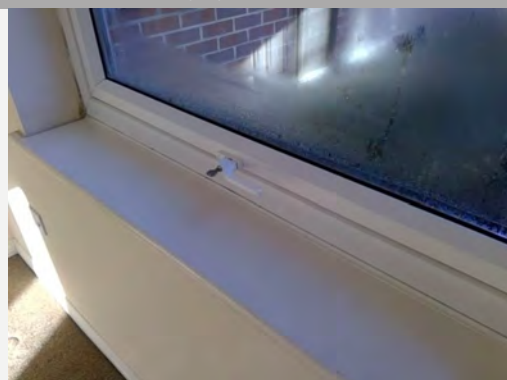
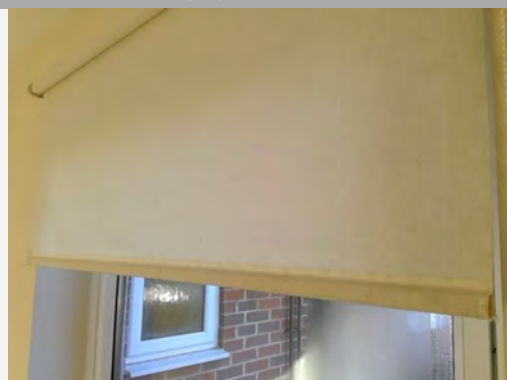
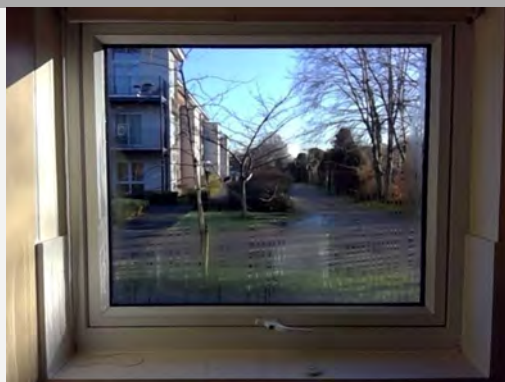
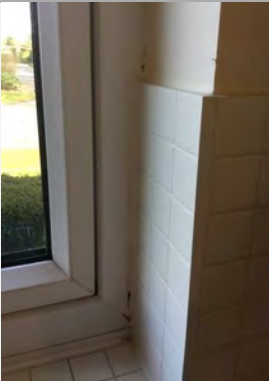
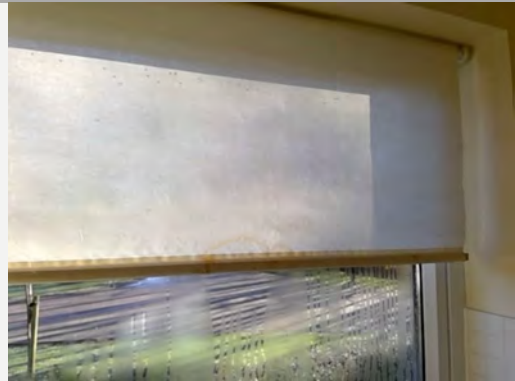
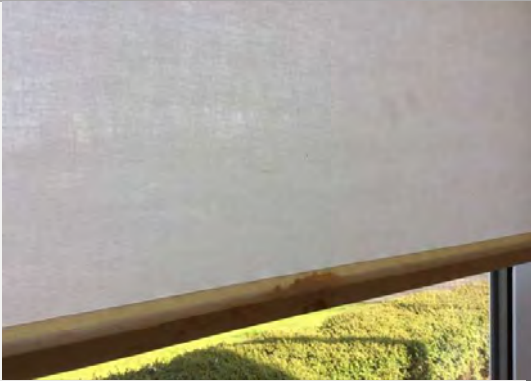
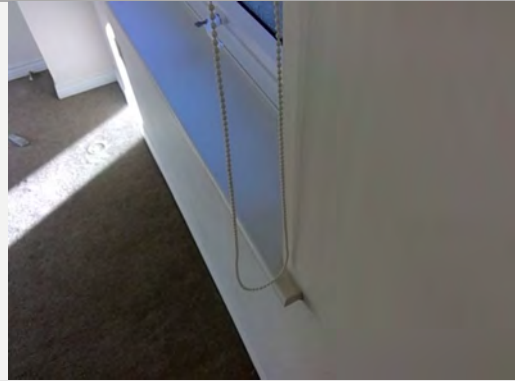
Name	No.	Description	Condition	Check Out Condition
Windows & Window Fittings	23	White UPVC windows, 2 sets; white handle, heavy blackening spot marks to the sealant to the corners; white rolled-edge windowsill and ceramic tiles to the kitchen by sink. Key present; white roller blind, plastic pull cord, not with a child breakage cord, water marks seen. Marks to frame; water marks to the white roller blind, no cleat fitted; black spot marks to the sealant, heavier to the right corner.	Used	No safety catch visible to blind
Lights & Electrical Fittings	24	White-fronted light switch; ceiling plastic rose, energy bulb fitted, 4-plate frosted shade; whitefronted plug socket, fuse socket and cooker point as fitted.	Used	Consistent with inventory
Cabinets	25	Flat laminate shaker-type cabinets with oval metal handles. All carcass are wooden, wall units have 2 shelves; sink unit, 1 shelf. Wall units have top and bottom plinths, matching kickplate to base units. Wall units from left to right: 4 sets of slimline units with up-and-over door for extractor fan, all units are clean. Floor units: double sink unit, 1 shelf with 1 door, wearing to the edge, laminate lifting to the kickplate to the corner underneath sink unit. Dummy drawer under oven, 4 pull-out drawers, white carcass; top carcass has manuals for oven, light marks seen to the carcass. Black mark to the back left corner to top draw, all drawers are fitted to runners.	Used	Consistent with inventory

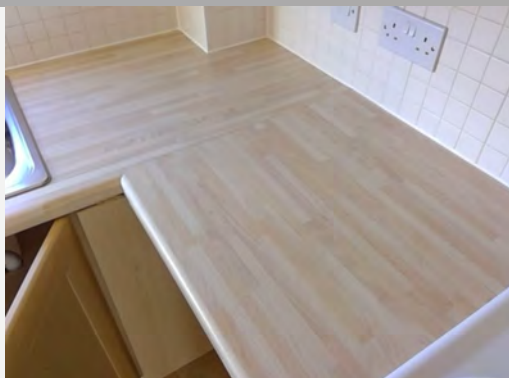
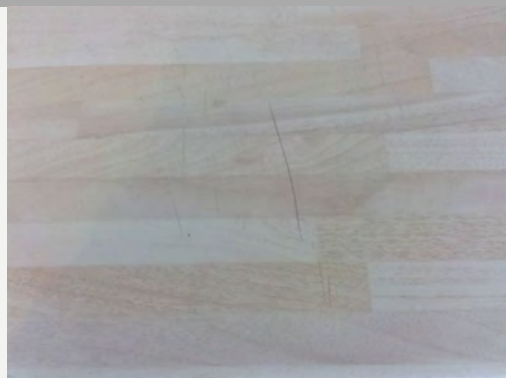
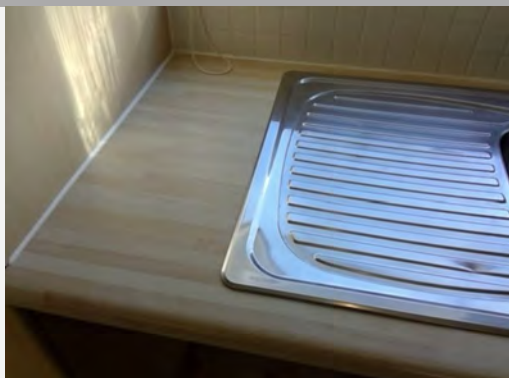
Kitchen - Counter-Tops

Counter-Tops	26	Beach-colour roll-edge laminate worktop, 3 sets of scratches to right of hob. Panstands and chopping boards to be used at all times; sealant: all good condition.	Used	Consistent with inventory

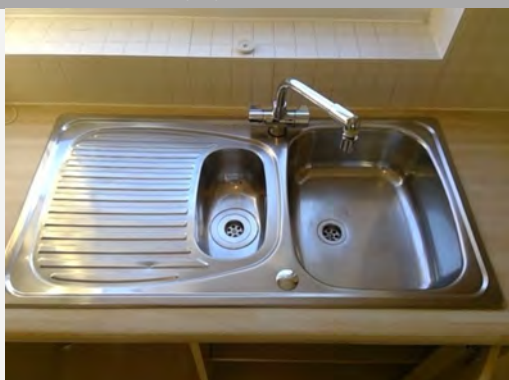
27.9

Name	No.	Description	Condition	Check Out Condition
Sink	27	1-1/2 stainless steel sink, white rubber plug; indent to the main sink, domestic scratches, has been professionally cleaned; chrome monobloc mixer tap. Limescale free.	Used	Consistent with inventory
Hob/ Oven	28	Chrome metal Electrolux extractor fan, grease free, professionally cleaned; new filter, 2 plastic light covers, fan is working, light working. White enamel Electrolux hob, controls to the right with red igniter light; light carbon marks seen around the rings but professionally cleaned. White enamel Beko oven, controls to the front, light working, fan working, 2 metal shelves with tray and grid, rubber doorseal intact; professionally cleaned.	Used	Consistent with inventory
Fridge/ Freezer	29	Integrated fridge/freezer, fridge, 4 glass shelves with white plastic edging, 1 crisp drawer, door shelves have 3 full door shelves, top shelf with lid; freezer has frost-free pull-out tray with further 3 trays; all professionally cleaned.	Used	Crack visible to compartment to door. Damage can be seen to pull out drawer within freezer

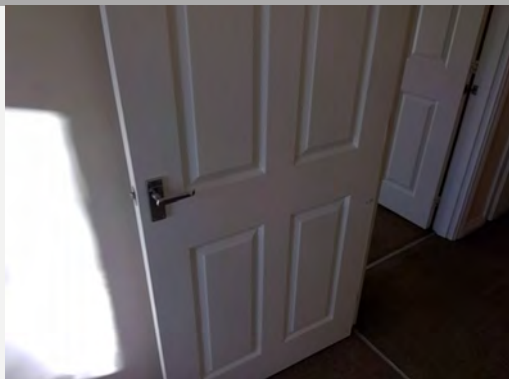
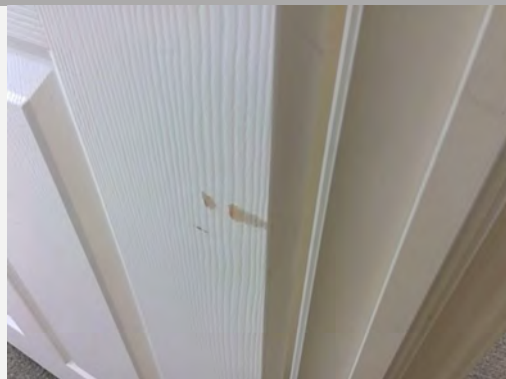
Bedroom - Doors & Woodwork

Name	No.	Description	Condition	Check Out Condition
Bedroom	30			Consistent with inventory
Doors & Woodwork	31	Wood grain-effect white panel door with chrome pull down lever handle. Exterior side: light scratches seen to the right upper level, chips to the paintwork underneath by door hinge, small chip to the bottom right corner. Metal threshold; reverse of door: reverse of handle; door frame painted white.	Used	Consistent with inventory

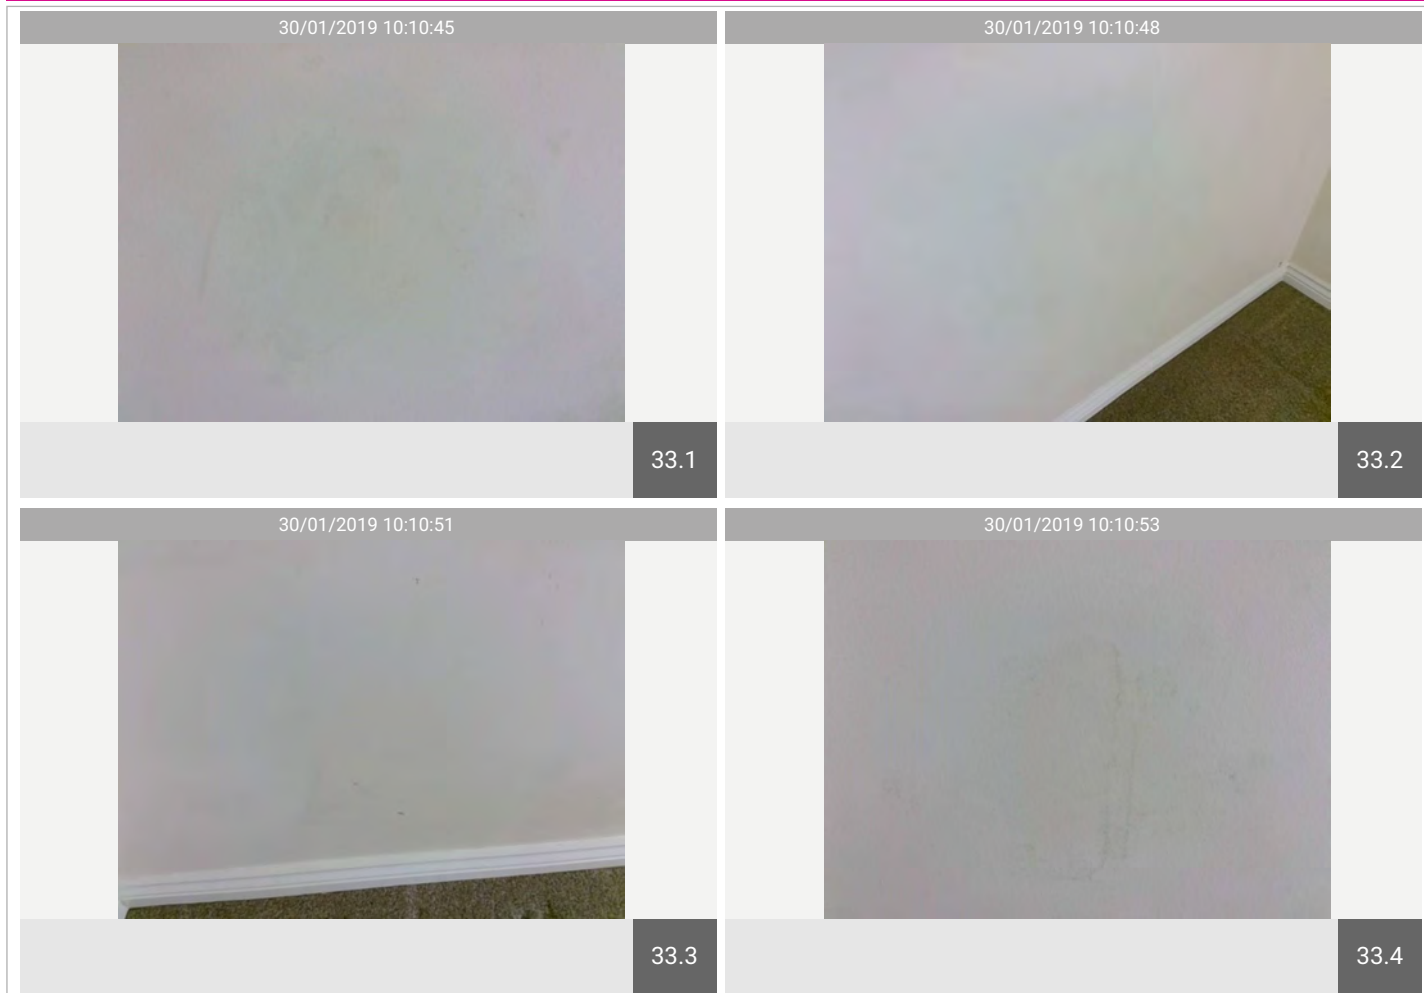
Bedroom - Walls

Name	No.	Description	Condition	Check Out Condition
Ceiling	32	White smooth painted ceiling, patchy paint noticeable, light scuff marks near back wall. Cobwebs to the corners.	Used	Consistent with inventory
Walls	33	Continuation of the cream smooth painted wall, patchy paint is noticeable, light blemish mark to the back wall by light switch. Heavier scuff marks to left wall to mid and lower level, to mid centre, and near facing wall. Scuff marks to the facing wall lower level and underneath windowsill, man-made cable hole to left and right-hand walls, further scuff marks to right-hand wall, touch-up paint and cleaning circle marks seen to centre. Skirting is white wooden, cable clips and cable seen to facing wall, light spot marks seen, metal doorstop with white rubber tip seen. Spot mark left of heater with heavy service scuff marks to right-hand wall in the facing corner.	Used	Consistent with inventory

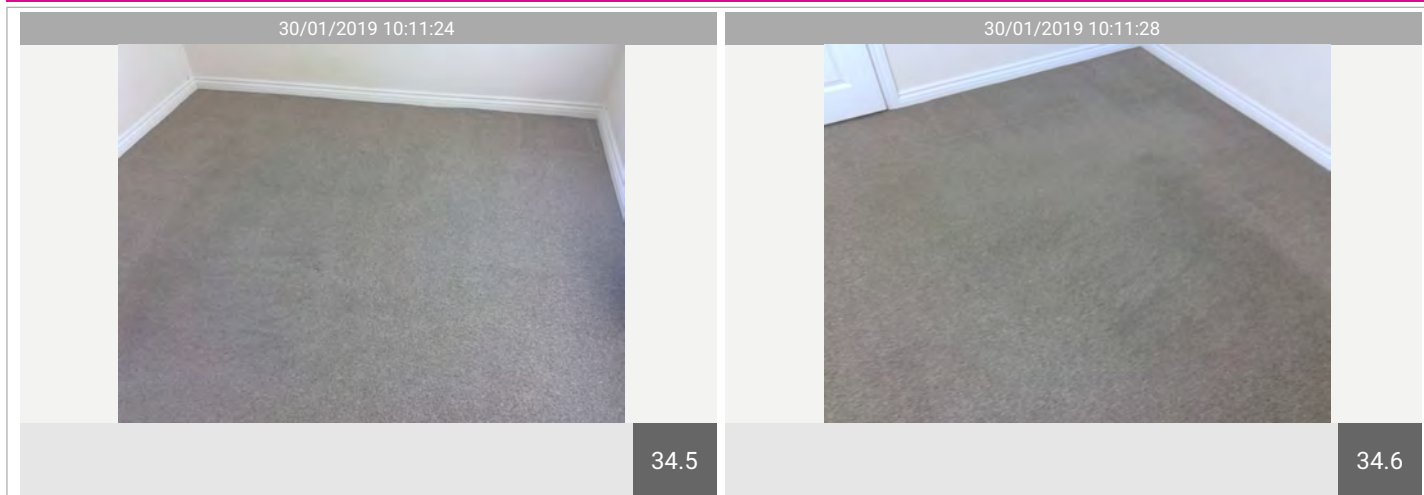
Bedroom - Floors

Floors	34	Continuation of brown fitted carpet, furniture indentations in places, has been professionally cleaned. Bits of fluff still noticeable to the facing right corner.	Used	Consistent with inventory
Windows and Window Fittings	35	White UPVC window, white handle, white UPVC frame, marks to sealant, white rolled-edge windowsill. Black spots are inside of the frame and underneath frame. Window vent fitted. Small hairline crack to recess of the wall, top left corner. White roller blind, fitted frame to the edge, not breakable plastic pull cord, no cleat	Used	No safety catch visible to roller blind chain
Heating	36	Wall-mounted flat electric heater as fitted.	Used	Consistent with inventory
Lights & Electrical Fittings	37	White-fronted light switch; ceiling plastic rose, energy bulb fitted, light working. No shade fitted, 2 white-fronted plug sockets, and fuse sockets as fitted.	Used	Consistent with inventory

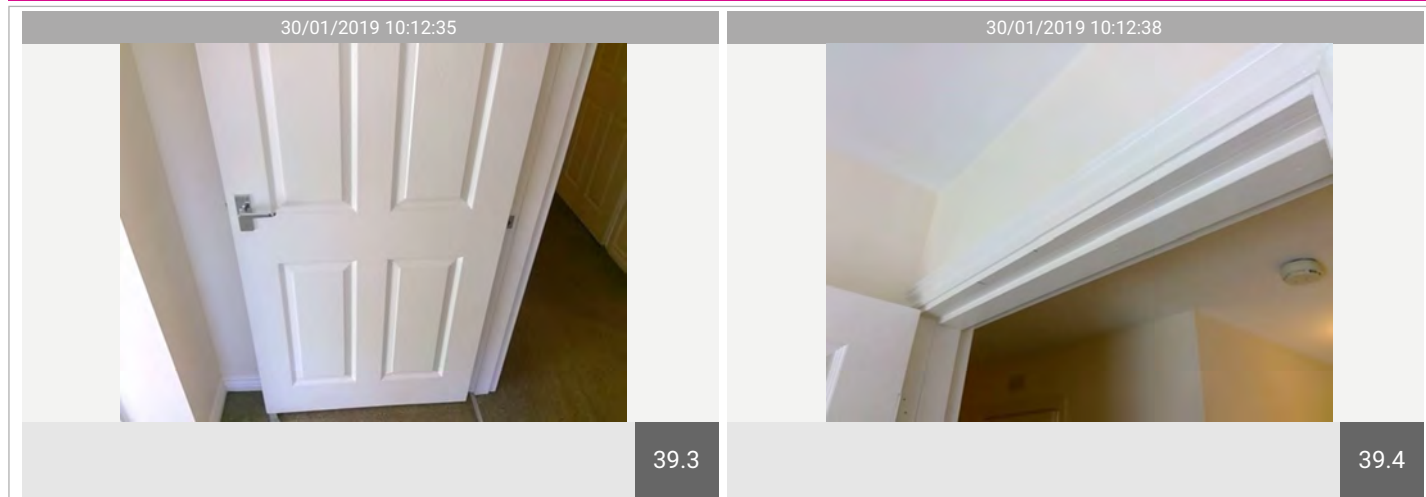
Bedroom 2 - Doors & Woodwork

Name	No.	Description	Condition	Check Out Condition
Bedroom 2	38			Consistent with inventory
Doors & Woodwork	39	<p>Wood grain-effect white panel door with chrome pull down lever handle.</p> <p>Fire door hinge fitted, door frame is painted white, chips to exterior, chips to the top recess of the door frame.</p> <p>Metal threshold.</p> <p>Interior side of door; reverse of handle, door frame white, light scratch mark by middle hinge and small chip to the right lower level.</p>	Used	Consistent with inventory
Ceiling	40	<p>White smooth painted ceiling.</p> <p>Brown spot marks to the back right corner.</p>	Used	Consistent with inventory
Walls	41	<p>Cream smooth painted walls with white painted wooden skirting, chrome doorstop with white rubber tip fitted, light in-use marks to the wood.</p> <p>Patchy paint is noticeable to all walls, small blemish mark to the back wall, finger marks around light switches.</p> <p>Facing wall: small scuff mark to left, further marks to the right of window with scuff marks underneath.</p> <p>Continuation of light scuff marks around plug sockets to mid and lower level to the right-hand wall; indent to the plaster, right side of double plug socket.</p> <p>Further rubber doorstop fitted, heavier marks to the skirting to the right-hand wall.</p> <p>Man-made cable hole to the facing left corner.</p>	Used	Consistent with inventory

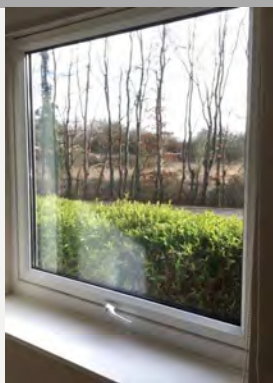
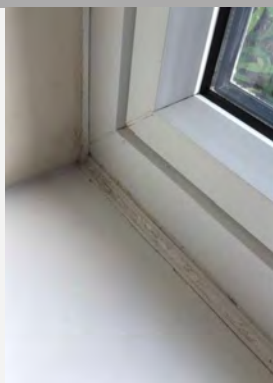
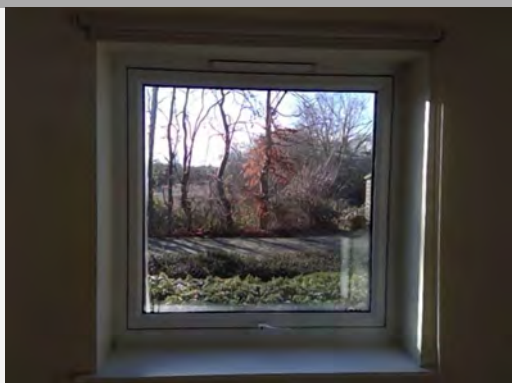
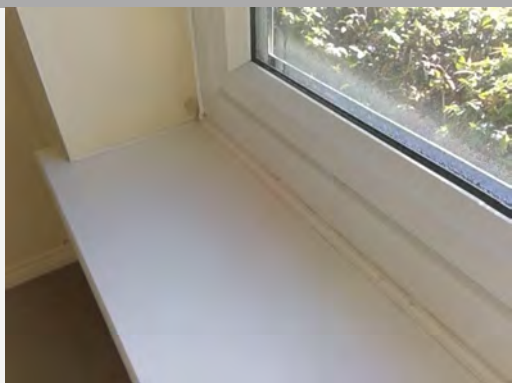
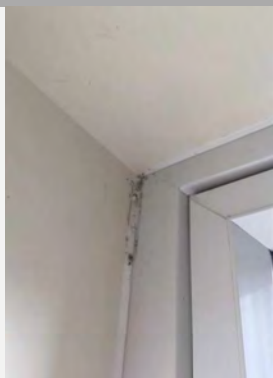
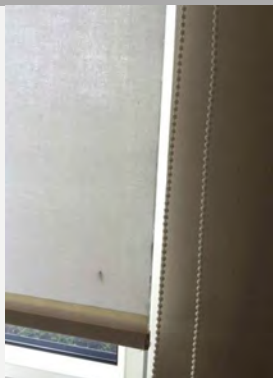
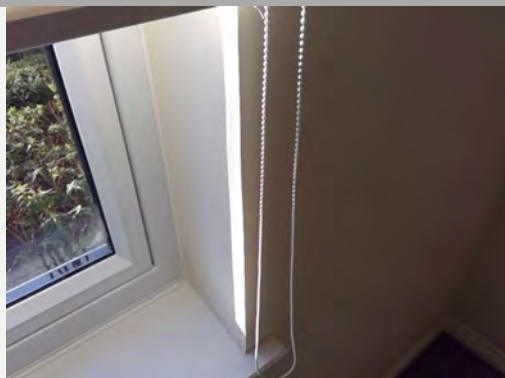
Bedroom 2 - Windows and Window Fittings

Name	No.	Description	Condition	Check Out Condition
Windows and Window Fittings	43	White UPVC window with white handle; white painted windowsill, blackening spots to the sealant; white roller blind with plastic pull cord. Blackening to the sealant to top left corner, fraying to the roller blind to the edge with black spot mark.	Used	No safety clasp has been fitted to roller blind chain
Heating	44	Wall-fitted flat electric heater as fitted.	Used	Consistent with inventory
Lights & Electrical Fittings	45	White-fronted single light switch; ceiling plastic rose, energy bulb fitted, 2-tier brown shade. Sockets, fuse sockets, telephone point and aerial socket are white-fronted as fitted; TV aerial cable noted.	Used	Consistent with inventory

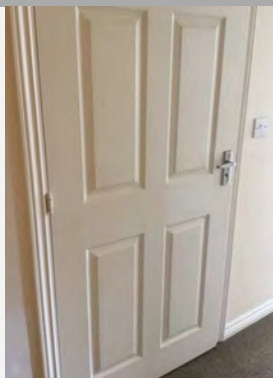
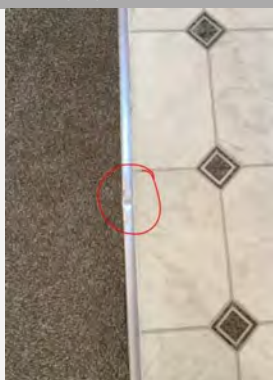
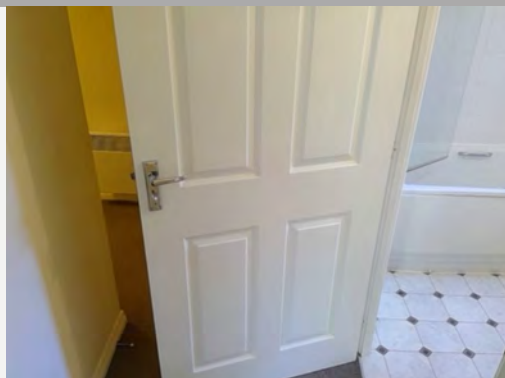
Bathroom - Doors & Woodwork

Name	No.	Description	Condition	Check Out Condition
Bathroom	46			Consistent with inventory
Doors & Woodwork	47	White panel grain-effect door, door frame painted white, chrome pull down lever handle; interior side: reverse of handle with thumblock. Metal threshold, indents seen.	Used	Consistent with inventory
Ceiling	48	White smooth painted ceiling, overpainted defect.	Used	Consistent with inventory
Walls	49	Cream smooth painted walls with white ceramic tiles with a pattern to the bath area. Underneath window: boxing-in near pipes, marks seen, sealant poor condition. Light marks to wall left of toilet. Continuation of white ceramic tiles to splashback. Wall-fitted silver framed mirror, smear free. Skirting is white wooden. Light discolouration in places.	Used	Consistent with inventory
Floors	50	Vinyl flooring, cream with a diamond motif. Sealant: good condition around the edges.	Used	Consistent with inventory

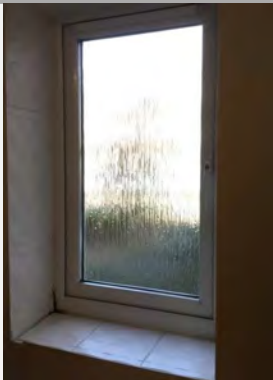
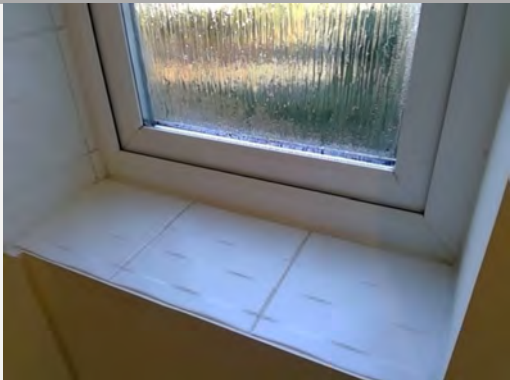
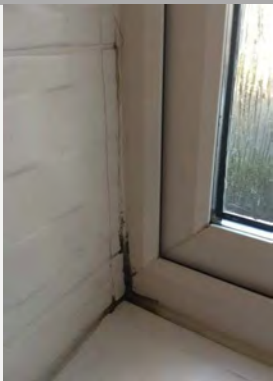
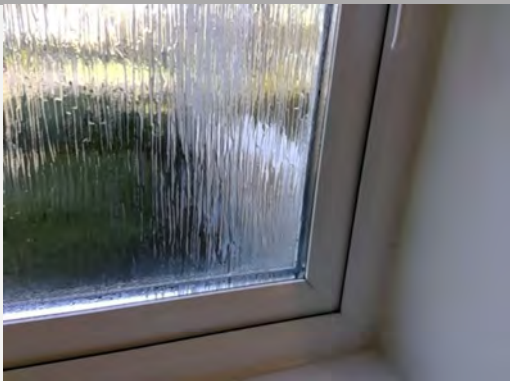
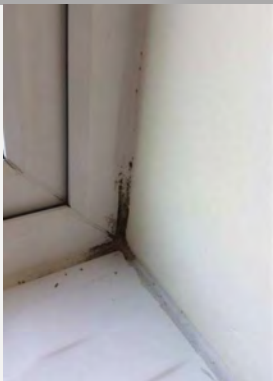
Bathroom - Windows & Window Fittings

Windows & Window Fittings	51	White UPVC window, obscure glass, white handle, window vent fitted. Heavy black mould to the left and right corners, ceramic tiles to the windowsill. Light speckles and mould seen to the windowsill.	Used	Consistent with inventory
Heating	52	Wall-fitted white casing Dimplex heater, pull cord, working fuse switch above door frame.	Used	Consistent with inventory
Lights & Electrical Fittings	53	[??] light switch, isolator switch above door frame; ceiling-fitted light, glass frosted shade, light working. Ceiling-fitted extractor fan, working.	Used	Consistent with inventory
