CHECK OUT INSPECTION

25 Park Way, Caversham, Reading, Berkshire, RG1 2KY

30/01/2019

2 Bedrooms Unfurnished Property

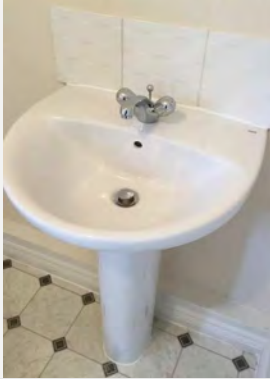
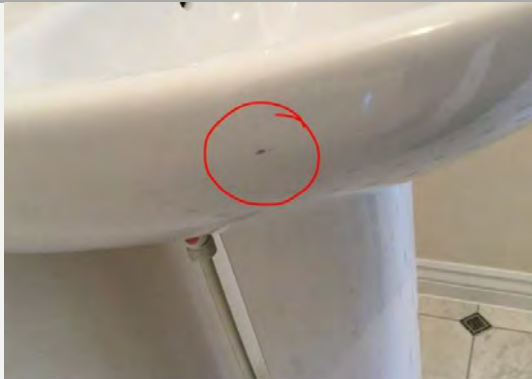
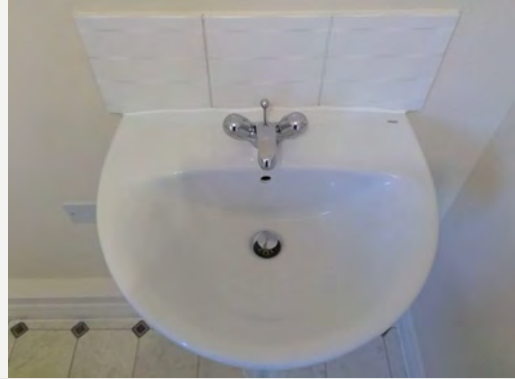
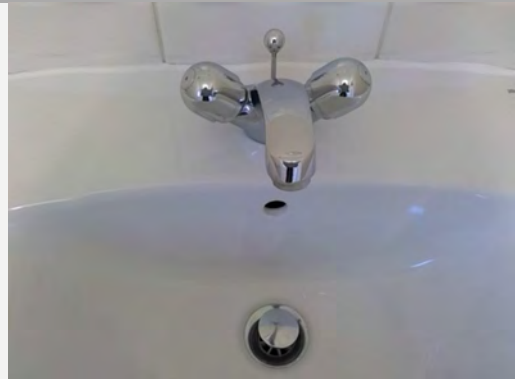
Bathroom - Basin

Name	No.	Description	Condition	Check Out Condition
Basin	54	Roca white pedestal basin, chrome pop-up plug, chrome mixer tap, pop-up plug mechanism behind, working; sealant: good condition, very small chip to the edge to the left. Photo and highlighted. Sealant all good condition to the pedestal.	Used	Consistent with inventory
Bath/ Shower	55	White acrylic enclosed bath with cream plastic bath panel, heavy gaps showing to the right; chrome grip handles with waste with metal chain with black rubber plug. Chrome mixer tap; chrome showerhead and hose fitted to bracket. Glass curved shower screen, all professionally cleaned, sealant is good condition.	Used	Consistent with inventory
Toilet	56	White WC Roca toilet; chrome push-in flusher, short and large; white plastic toilet seat, flusher working, bowl clean. Light marks to the sealant around pedestal.	Used	Hairline crack can be seen to back of the toilet

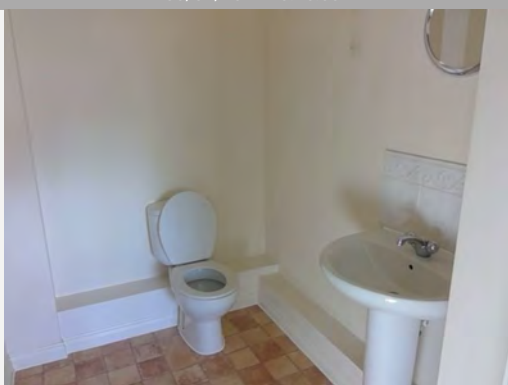
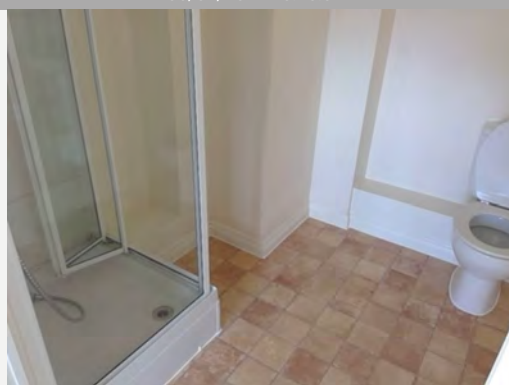
Name	No.	Description	Condition	Check Out Condition
En-Suite	57			Consistent with inventory
Door & Hardware	58	White panelled wood grain-effect door and door frame, chrome pull down lever handle; light blackening to the hinges going onto door frame. Interior side of door: reverse of handle with thumblock, smear mark to the handle, metal threshold.	Used	Consistent with inventory
Ceiling	59	White smooth painted ceiling.	Used	Consistent with inventory
Walls & Skirting	60	Cream smooth painted walls with white ceramic tiles with border pattern seen some discolouration to the grout to the shower area. Marks to top of boxing-in to left wall, skirting is white, various wear marks seen; further marks to the right-hand wall left side of pedestal basin with blackening to the sealant; marks to the facing wall, left of toilet. Circle mark seen. Wall-fitted reflected mirror, smear free.	Used	Consistent with inventory

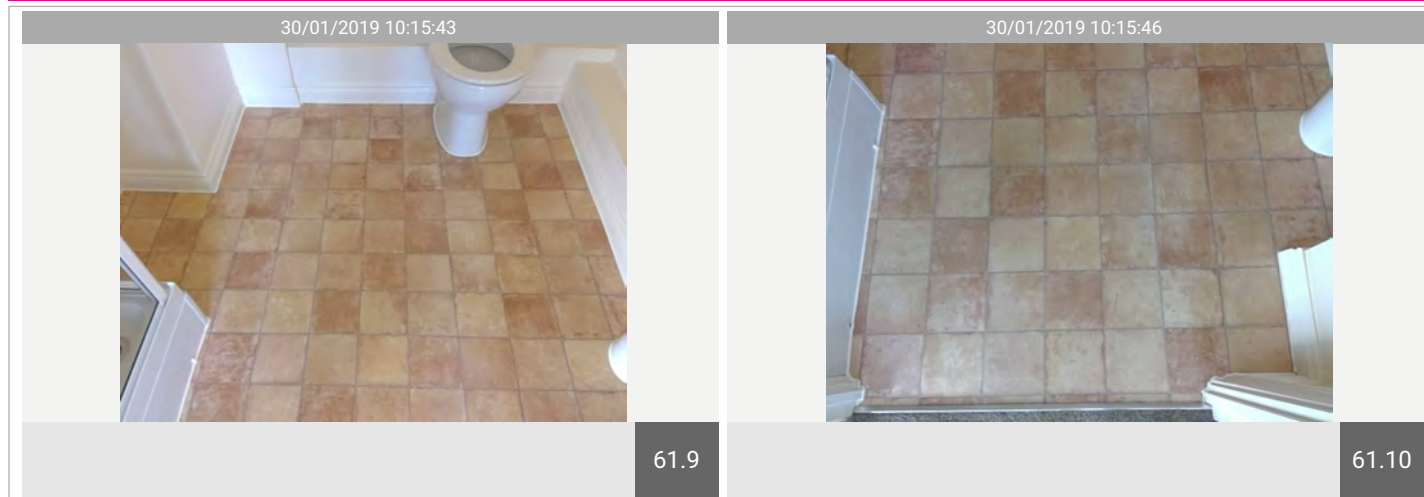
En-Suite - Flooring

Flooring	61	Terracotta vinyl tiled-effect flooring, clean. Sealant: fair condition.	Used	Consistent with inventory
Lights & Electrical Fittings	62	White-fronted light switch and isolator switch in bedroom, ceiling-fitted light, energy bulb fitted; frosted 4 glass plate shade, working; ceiling-fitted extractor fan, working.	Used	Consistent with inventory
Heating	63	Wall-fitted Dimplex heater with pull cord working, fuse switch above door	Used	Consistent with inventory

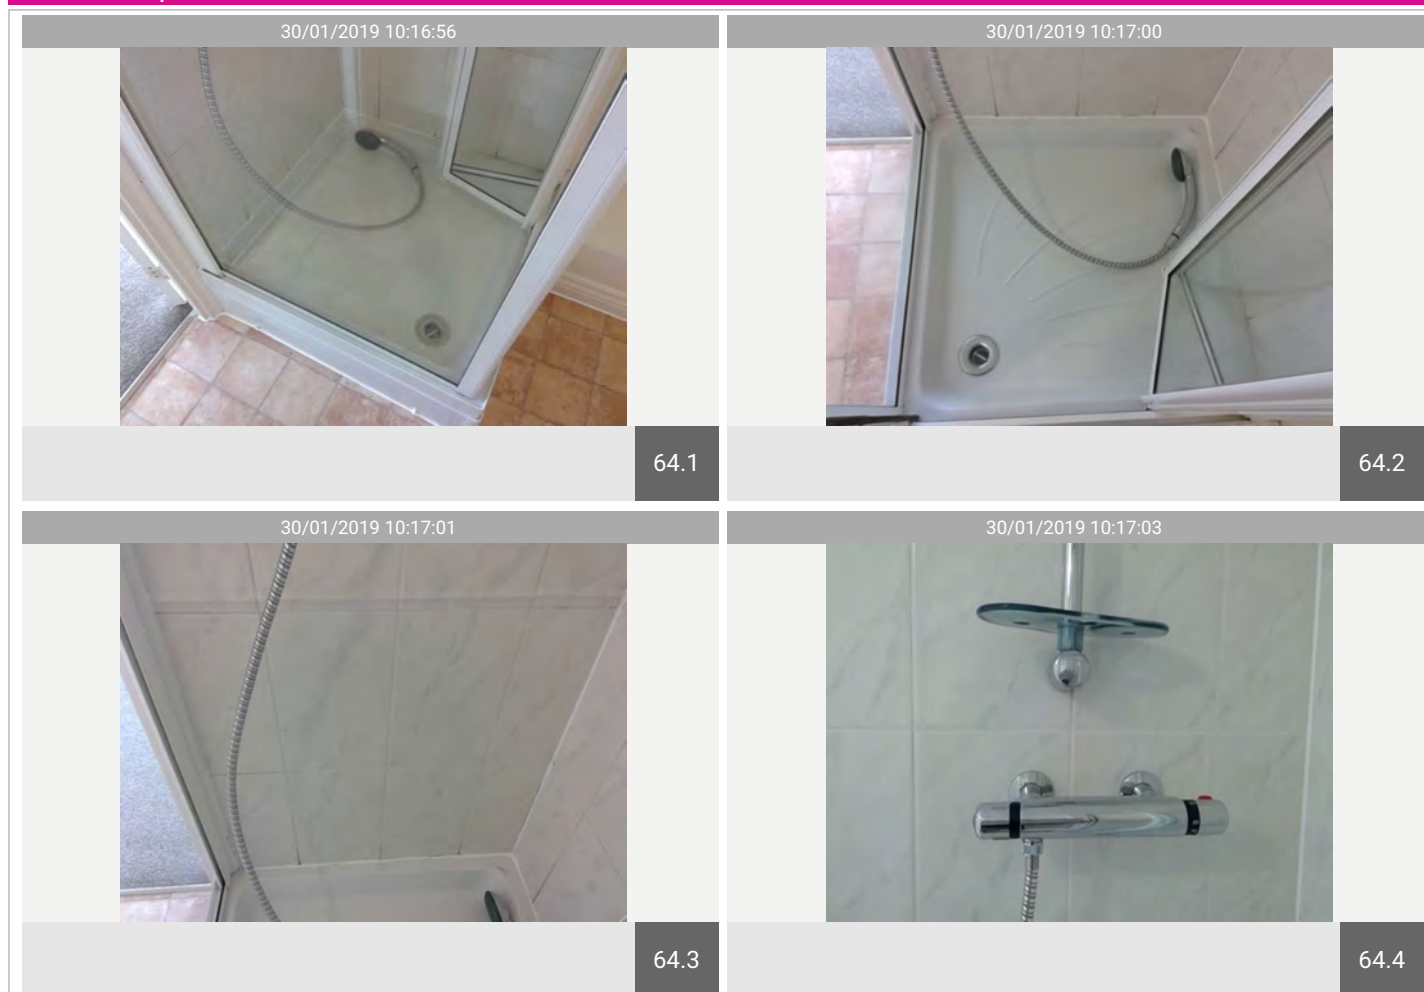
En-Suite - Bath/ Shower

Name	No.	Description	Condition	Check Out Condition
Bath/ Shower	64	White frame bifold corner shower built up on a white plinth, 2 screw caps missing; sealant: fair condition; has been professionally cleaned; white shower tray, chrome waste top missing, marks to the sealant. Marks to the corners of the doors and the rubber seal. Wall-fitted thermostat control shower bar with a brass-effect shower hose, chrome showerhead fitted to shower riser with plastic double soap dish, professionally cleaned.	Used	Consistent with inventory
Toilet	65	White WC with chrome short and long flusher, Roca, flusher working; white plastic toilet seat, chrome hinges, marks to the ceiling, bowl clean.	Used	Consistent with inventory
Basin	66	White ceramic basin, pedestal; chrome mixer tap, smear marked, plug mechanism behind; pop-up plug: lightly tarnished and wearing; sealant: good condition.	Used	Consistent with inventory
